**Flood Control Project Maintenance
Levee Inspections**
LMA District Cover Sheet
Spring 2019 Levee Inspection Results

American River Flood Control District

Spring 2019 Levee Inspection Results

Waterway			Bank	Unit Miles
Unit No. 01 Arcade Creek			Left	2.08
	Spring (March - May)	Summer (June - August)	(September - November) Fall	Winter (December - February)
Unit Maintenance Rating (Fall Only)				
Date of Inspection	5/14/2019 - 5/14/2019			
DWR Inspector	Luz Dial			
Accompanied By	Ross Kawamura ARFCD

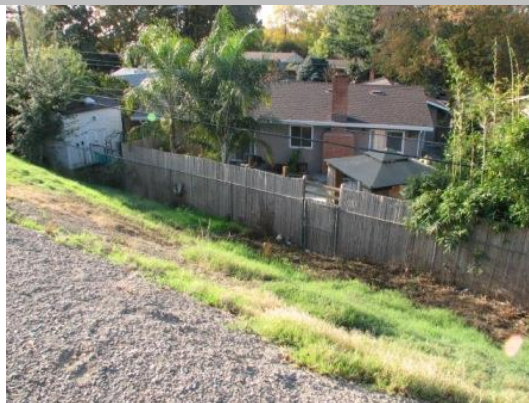
Photo 2 of 2 : SP_2019_NA0001_55_8_20190307_00009.jpg

LM Start	3.90	Rating **	U	Issue No.	8 (cont)	
LM End	3.90	Issue Type +	En	Location *	LS	
Category	Earthen Levee			GPS Latitude/Longitude		
				Start	End	
Item	Encroachments			38.586327 °	38.586327 °	
				-121.447373 °	-121.447373 °	
DWR ID	DWR_NA0001_04_s _ 2012_8					
Comment Code						
FE : Fence						
Inspector Comment						
A bamboo privacy fence within 10-ft of the landside toe obstructs visibility.

Fall 2009 photo: Fence and landscaping within 10-ft of levee toe obstructs access and visibility.

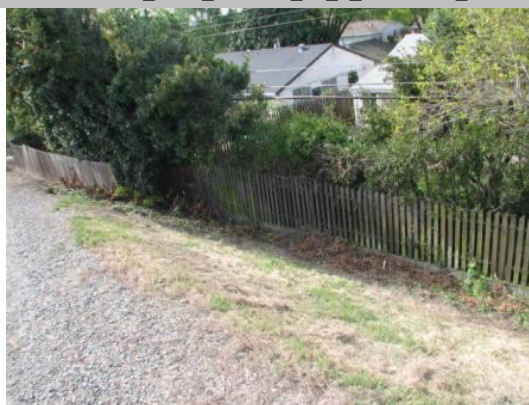
Photo 1 of 1 : SP_2019_NA0001_55_6_20190307_00007.jpg

LM Start	3.92	Rating **	U	Issue No.	6
LM End	3.92	Issue Type +	En	Location *	LS
Category	Earthen Levee			GPS Latitude/Longitude	
				Start	End
Item	Encroachments			38.586154 °	38.586154 °
				-121.447115 °	-121.447115 °
DWR ID	DWR_NA0001_04_s _ 2012_6				
Comment Code					
FE : Fence					
Inspector Comment					
A privacy fence within 10-ft of the landside toe obstructs visibility.

04/14/2011 Landscaping has been removed; however, a wooden fence is still obstructing access and visibility.

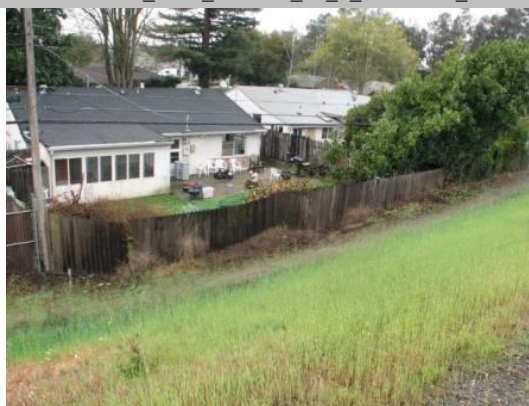
Photo 1 of 1 : SP_2019_NA0001_55_9_20190307_00010.jpg

LM Start	3.93	Rating **	U	Issue No.	9
LM End	3.93	Issue Type +	En	Location *	LS
Category	Earthen Levee			GPS Latitude/Longitude	
				Start	End
Item	Encroachments			38.586047 °	38.586047 °
				-121.446975 °	-121.446975 °
DWR ID	DWR_NA0001_04_s _ 2012_9				
Comment Code					
FE : Fence					
Inspector Comment					
Wooden privacy fence on the levee slope obstructs access and visibility.

03/16/2012 Wood privacy fence completely obstructs access and visibility.

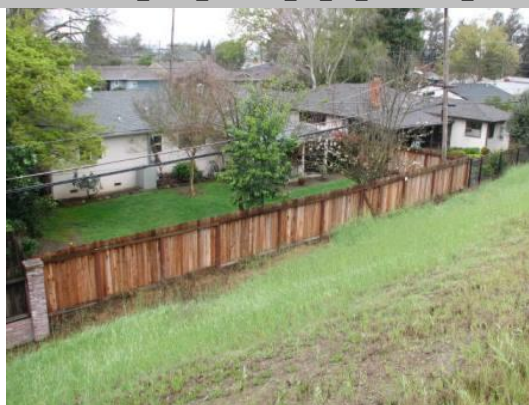
Photo 1 of 1 : SP_2019_NA0001_55_11_20190307_00011.jpg

LM Start	3.97	Rating **	U	Issue No.	11
LM End	3.97	Issue Type +	En	Location *	LS
Category	Earthen Levee			GPS Latitude/Longitude	
				Start	End
Item	Encroachments			38.585639 °	38.585639 °
				-121.446451 °	-121.446451 °
DWR ID	DWR_NA0001_04_s _ 2012_11				
Comment Code					
FE : Fence					
Inspector Comment					
Privacy fence and landscaping within 10-ft of the levee toe obstruct access and visibility.

03/16/2012 Wood privacy fence completely obstructs access and visibility.

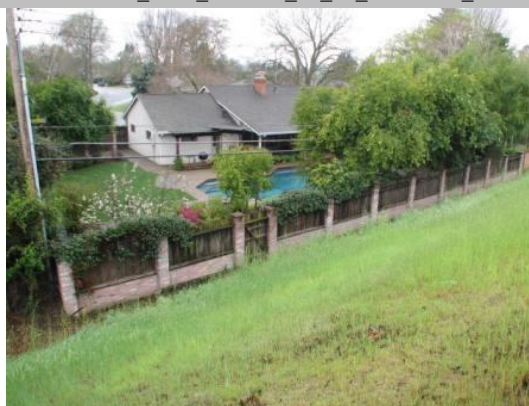
Photo 1 of 1 : SP_2019_NA0001_55_12_20190307_00012.jpg

LM Start	3.98	Rating **	U	Issue No.	12
LM End	3.98	Issue Type +	En	Location *	LS
Category	Earthen Levee			GPS Latitude/Longitude	
				Start	End
Item	Encroachments			38.585496 °	38.585496 °
				-121.446309 °	-121.446309 °
DWR ID	DWR_NA0001_04_s_2012_12				
Comment Code					
FE : Fence					
Inspector Comment					
Privacy fence and landscaping within 10-ft of the levee toe obstruct access and visibility.

03/16/2012 Wood privacy fence completely obstructs access and visibility.

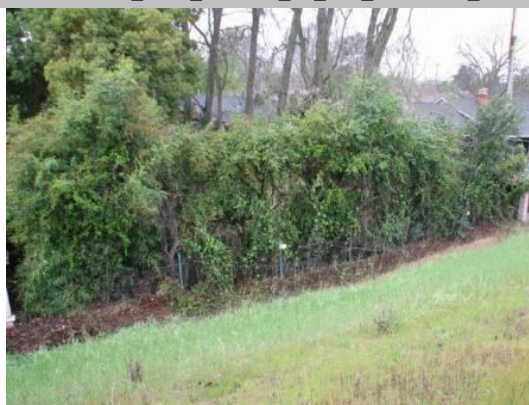
Photo 1 of 1 : SP_2019_NA0001_55_112_20190307_00100.jpg

LM Start	3.99	Rating **	U	Issue No.	112
LM End	3.99	Issue Type +	En	Location *	LS
Category	Earthen Levee			GPS Latitude/Longitude	
				Start	End
Item	Vegetation			38.585385°	38.585385°
				-121.446168°	-121.446168°
DWR ID	DWR_NA0001_04_s_2012_112				
Comment Code					
V6 : Landscaping					
Inspector Comment					
Landscaping completely blocks visibility.

03/16/2012 Landscape obstructs visibility and access.

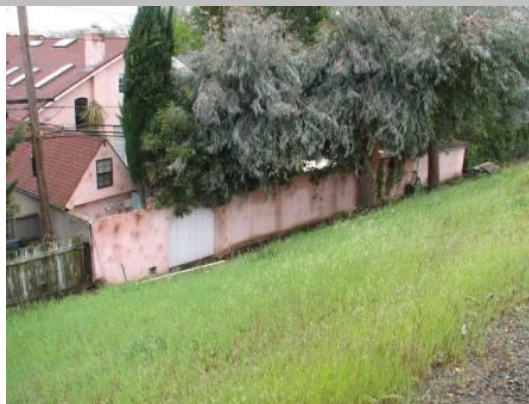
Photo 1 of 1 : SP_2019_NA0001_55_13_20190307_00013.jpg

LM Start	4.00	Rating **	U	Issue No.	13
LM End	4.00	Issue Type +	En	Location *	LS
Category	Earthen Levee			GPS Latitude/Longitude	
				Start	End
Item	Encroachments			38.585325 °	38.585325 °
				-121.446059 °	-121.446059 °
DWR ID	DWR_NA0001_04_s_2012_13				
Comment Code					
FE : Fence					
Inspector Comment					
Pink cement block fence obstructs access and visibility.

03/16/2012 Concrete wall obstructs access and visibility.

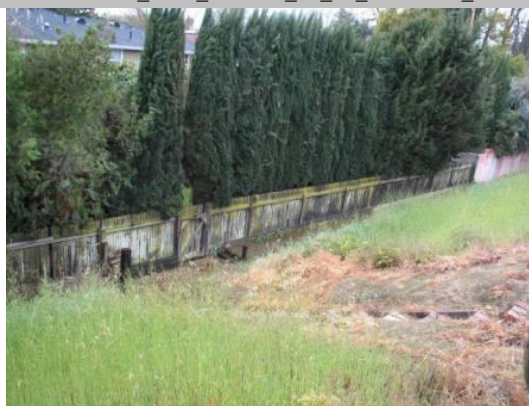
Photo 1 of 1 : SP_2019_NA0001_55_14_20190307_00014.jpg

LM Start	4.02	Rating **	U	Issue No.	14
LM End	4.02	Issue Type +	En	Location *	LS
Category	Earthen Levee			GPS Latitude/Longitude	
				Start	End
Item	Encroachments			38.585175 °	38.585175 °
				-121.445883 °	-121.445883 °
DWR ID	DWR_NA0001_04_s_2012_14				
Comment Code					
FE : Fence					
Inspector Comment					
Privacy fence and helix pencil shrubs planted within 10-ft of the levee toe obstruct access and visibility.

03/16/2012 Wood privacy fence completely obstructs access and visibility.

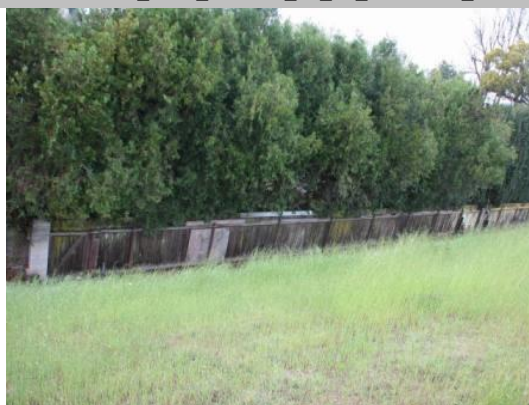
Photo 1 of 1 : SP_2019_NA0001_55_15_20190307_00015.jpg

LM Start	4.03	Rating **	U	Issue No.	15
LM End	4.03	Issue Type +	En	Location *	LS
Category	Earthen Levee			GPS Latitude/Longitude	
				Start	End
Item	Encroachments			38.585021 °	38.585021 °
				-121.445678 °	-121.445678 °
DWR ID	DWR_NA0001_04_s_2012_15				
Comment Code					
FE : Fence					
Inspector Comment					
Privacy fence and evergreen shrub landscaping within 10-ft of the levee toe obstruct access and visibility.

03/16/2012 Wood privacy fence completely obstructs access and visibility.

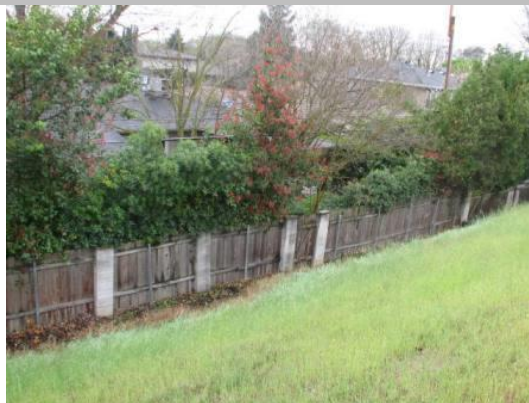
Photo 1 of 1 : SP_2019_NA0001_55_16_20190307_00016.jpg

LM Start	4.04	Rating **	U	Issue No.	16
LM End	4.04	Issue Type +	En	Location *	LS
Category	Earthen Levee			GPS Latitude/Longitude	
				Start	End
Item	Encroachments			38.584885 °	38.584885 °
				-121.445520 °	-121.445520 °
DWR ID	DWR_NA0001_04_s_2012_16				
Comment Code					
FE : Fence					
Inspector Comment					
Privacy fence and landscaping within 10-ft of the levee toe obstruct access and visibility.

03/16/2012 Wood privacy fence completely obstructs access and visibility.

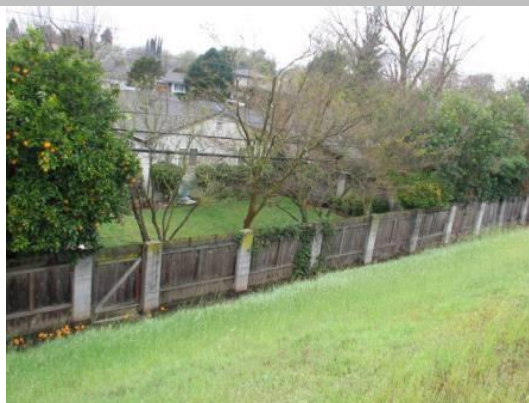
Photo 1 of 1 : SP_2019_NA0001_55_17_20190307_00017.jpg

LM Start	4.05	Rating **	U	Issue No.	17
LM End	4.05	Issue Type +	En	Location *	LS
Category	Earthen Levee			GPS Latitude/Longitude	
				Start	End
Item	Encroachments			38.584810 °	38.584810 °
				-121.445403 °	-121.445403 °
DWR ID	DWR_NA0001_04_f_2018_17				
Comment Code					
FE : Fence					
Inspector Comment					
Privacy fence and maple tree landscaping within 10-ft of the levee toe obstruct access and visibility.

03/16/2012 Wood privacy fence completely obstructs access and visibility.

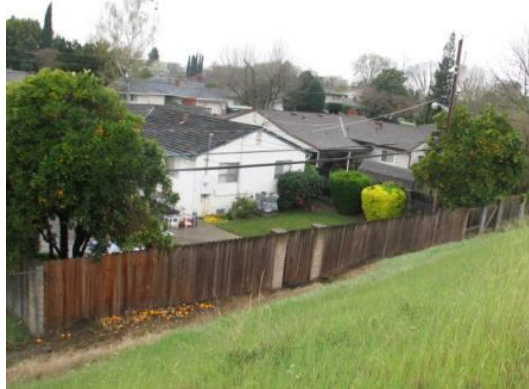
Photo 1 of 1 : SP_2019_NA0001_55_18_20190307_00018.jpg

LM Start	4.06	Rating **	U	Issue No.	18
LM End	4.06	Issue Type +	En	Location *	LS
Category	Earthen Levee			GPS Latitude/Longitude	
				Start	End
Item	Encroachments			38.584694 °	38.584694 °
				-121.445255 °	-121.445255 °
DWR ID	DWR_NA0001_04_s_2012_18				
Comment Code					
FE : Fence					
Inspector Comment					
Wooden fence between orange trees is within 10-ft of the levee toe.

03/16/2012 Wood privacy fence completely obstructs access and visibility.

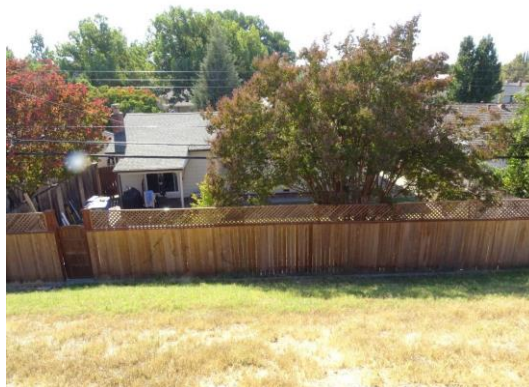
Photo 1 of 1 : SP_2019_NA0001_55_284_20190307_00211.jpg

LM Start	4.08	Rating **	U	Issue No.	284
LM End	4.08	Issue Type +	En	Location *	LS
Category	Earthen Levee			GPS Latitude/Longitude	
				Start	End
Item	Encroachments			38.584556 °	38.584556 °
				-121.445103 °	-121.445103 °
DWR ID	DWR_NA0001_04_f_2018_284				
Comment Code					
FE : Fence					
Inspector Comment					
Wooden fence on levee toe blocks visibility and access.

View of wooden fence on levee toe. Fall 2018

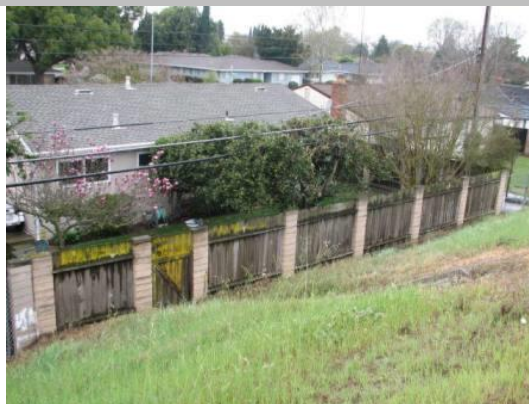
Photo 1 of 1 : SP_2019_NA0001_55_19_20190307_00019.jpg

LM Start	4.09	Rating **	U	Issue No.	19
LM End	4.09	Issue Type +	En	Location *	LS
Category	Earthen Levee			GPS Latitude/Longitude	
				Start	End
Item	Encroachments			38.584459 °	38.584459 °
				-121.444951 °	-121.444951 °
DWR ID	DWR_NA0001_04_s_2012_19				
Comment Code					
FE : Fence					
Inspector Comment					
A privacy fence within 10-ft of the levee toe obstructs access and visibility.

03/16/2012 Wood privacy fence completely obstructs access and visibility.

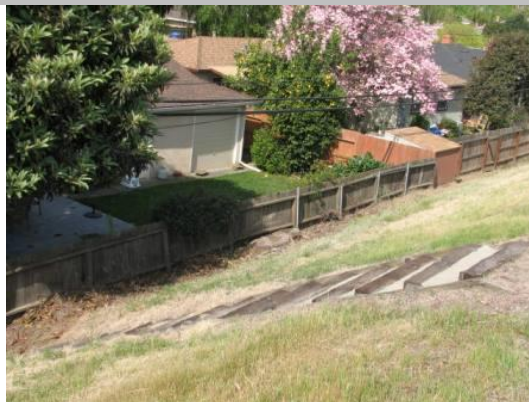
Photo 1 of 1 : SP_2019_NA0001_55_21_20190307_00021.jpg

LM Start	4.12	Rating **	U	Issue No.	21
LM End	4.12	Issue Type +	En	Location *	LS
Category	Earthen Levee			GPS Latitude/Longitude	
				Start	End
Item	Vegetation			38.584129 °	38.584129 °
				-121.444485 °	-121.444485 °
DWR ID	DWR_NA0001_04_s _ 2012_21				
Comment Code					
V6 : Landscaping					
Inspector Comment					
Landscaping on the levee slope, as well as the wooden privacy fence, are within 10-ft of the levee toe and obstruct access and visibility.

04/14/2011 Palms have been removed.

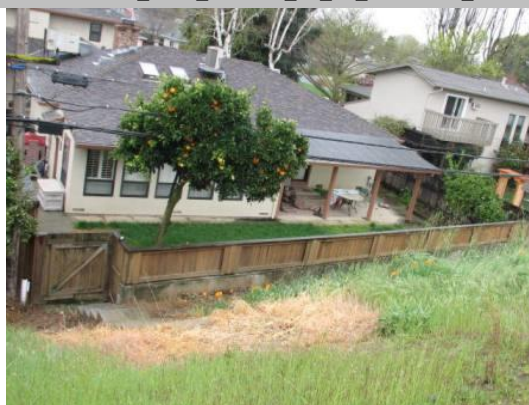
Photo 1 of 1 : SP_2019_NA0001_55_23_20190307_00023.jpg

LM Start	4.14	Rating **	U	Issue No.	23
LM End	4.14	Issue Type +	En	Location *	LS
Category	Earthen Levee			GPS Latitude/Longitude	
				Start	End
Item	Encroachments			38.583935 °	38.583935 °
				-121.444150 °	-121.444150 °
DWR ID	DWR_NA0001_04_s_2012_23				
Comment Code					
FE : Fence					
Inspector Comment					
Cement block and wooden fence obstruct visibility.

03/16/2012 Wooden fence on cement wall obstructs access and visibility.

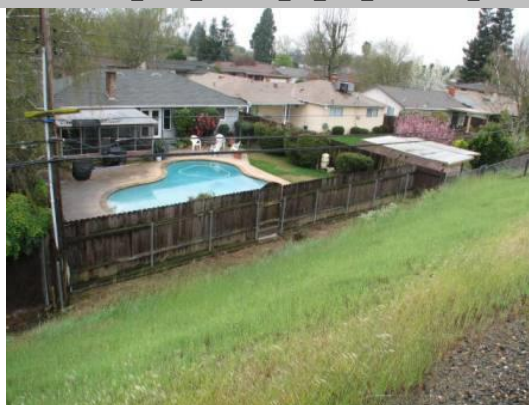
Photo 1 of 1 : SP_2019_NA0001_55_190_20190307_00159.jpg

LM Start	4.19	Rating **	U	Issue No.	190
LM End	4.19	Issue Type +	En	Location *	LS
Category	Earthen Levee			GPS Latitude/Longitude	
				Start	End
Item	Vegetation			38.583559 °	38.583559 °
				-121.443485 °	-121.443485 °
DWR ID	DWR_NA0001_04_s _ 2012_190				
Comment Code					
V6 : Landscaping					
Inspector Comment					
Planter boxes are built into levee slope. A wooden fence obstructs visibility. A pool is just outside 10-ft from the levee toe.

03/16/2012 Wood privacy fence completely obstructs access and visibility.

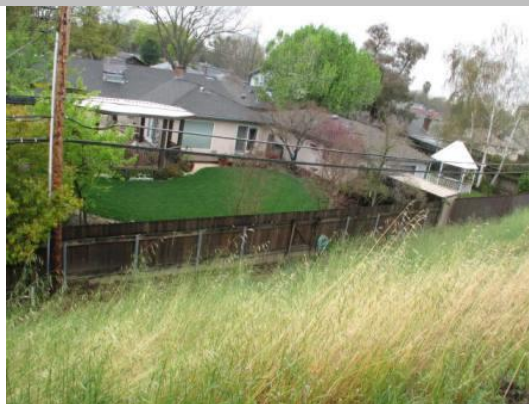
Photo 1 of 1 : SP_2019_NA0001_55_191_20190307_00160.jpg

LM Start	4.21	Rating **	U	Issue No.	191
LM End	4.21	Issue Type +	En	Location *	LS
Category	Earthen Levee			GPS Latitude/Longitude	
				Start	End
Item	Encroachments			38.583355 °	38.583355 °
				-121.443123 °	-121.443123 °
DWR ID	DWR_NA0001_04_s _ 2012_191				
Comment Code					
FE : Fence					
Inspector Comment					
A wooden privacy fence is within 10-ft of the levee toe and obstructs access and visibility.

03/16/2012 Wood privacy fence completely obstructs access and visibility.

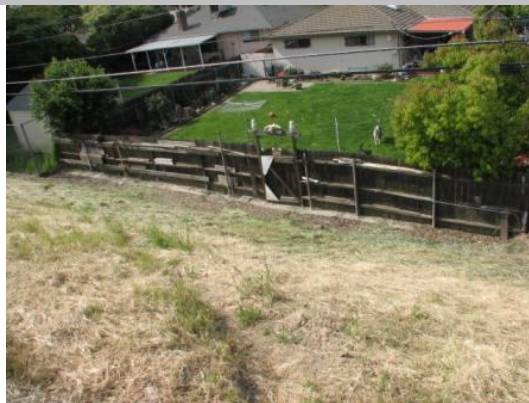
Photo 1 of 1 : SP_2019_NA0001_55_24_20190307_00024.jpg

LM Start	4.22	Rating **	U	Issue No.	24
LM End	4.22	Issue Type +	En	Location *	LS
Category	Earthen Levee			GPS Latitude/Longitude	
				Start	End
Item	Encroachments			38.583265 °	38.583265 °
				-121.442965 °	-121.442965 °
DWR ID	DWR_NA0001_04_s_2012_24				
Comment Code					
FE : Fence					
Inspector Comment					
Wooden privacy fence obstructs visibility. On 04/14/2011, retaining wall was removed.

04/14/2011 Retaining wall has been removed. Wooden fence remains and is obstructing access and visibility.

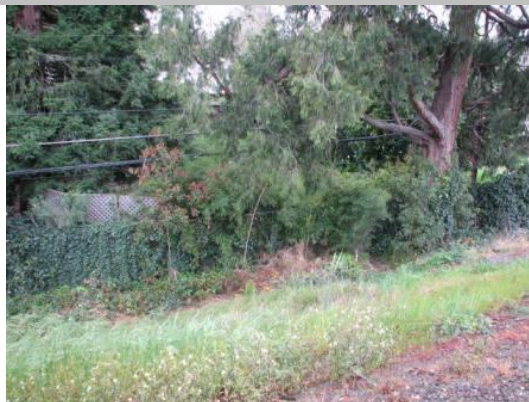
Photo 1 of 1 : SP_2019_NA0001_55_192_20190307_00161.jpg

LM Start	4.25	Rating **	U	Issue No.	192
LM End	4.25	Issue Type +	En	Location *	LS
Category	Earthen Levee			GPS Latitude/Longitude	
				Start	End
Item	Vegetation			38.583031 °	38.583031 °
				-121.442620 °	-121.442620 °
DWR ID	DWR_NA0001_04_s_2012_192				
Comment Code					
V6 : Landscaping					
Inspector Comment					
Ivy and vine growth on the cyclone fence obstruct visibility. Steps and landscaping are built up the levee slope.

03/16/2012 Landscaping on fence obstructs visibility and access.

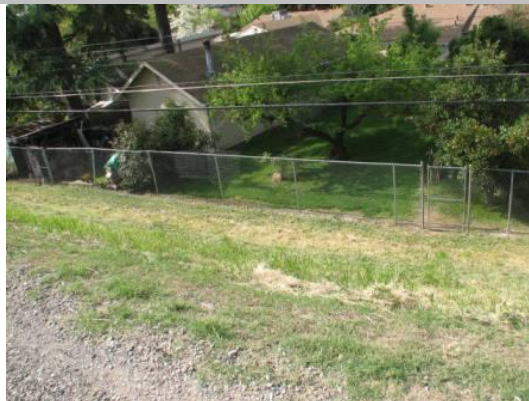
Photo 1 of 1 : SP_2019_NA0001_55_194_20190307_00162.jpg

LM Start	4.28	Rating **	M	Issue No.	194
LM End	4.28	Issue Type +	En	Location *	LS
Category	Earthen Levee			GPS Latitude/Longitude	
				Start	End
Item	Encroachments			38.582716 °	38.582716 °
				-121.442128 °	-121.442128 °
DWR ID	DWR_NA0001_04_s_2012_194				
Comment Code					
FE : Fence					
Inspector Comment					
Chainlink fence with vegetation obstructs access and visibility.

04/14/2011 Planter boxes have been removed. Chainlink fence partially blocks access.

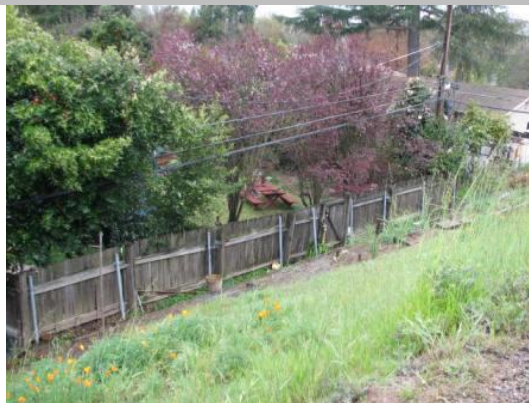
Photo 1 of 1 : SP_2019_NA0001_55_26_20190307_00025.jpg

LM Start	4.31	Rating **	U	Issue No.	26
LM End	4.31	Issue Type +	En	Location *	LS
Category	Earthen Levee			GPS Latitude/Longitude	
				Start	End
Item	Encroachments			38.582479 °	38.582479 °
				-121.441768 °	-121.441768 °
DWR ID	DWR_NA0001_04_s_2012_26				
Comment Code					
FE : Fence					
Inspector Comment					
Wooden fence within 10-ft of the levee toe. Garden and ramp built on levee slope.

03/16/2012 Wood privacy fence completely obstructs access and visibility.

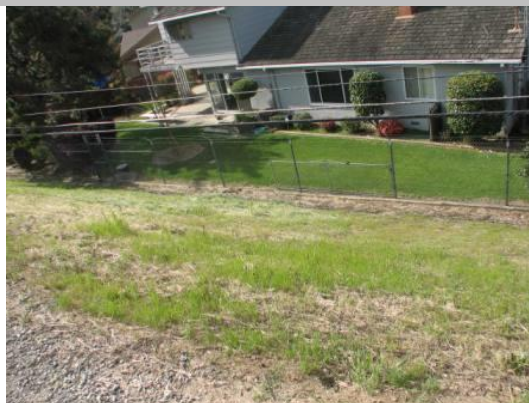
Photo 1 of 1 : SP_2019_NA0001_55_195_20190307_00163.jpg

LM Start	4.32	Rating **	M	Issue No.	195
LM End	4.32	Issue Type +	En	Location *	LS
Category	Earthen Levee			GPS Latitude/Longitude	
				Start	End
Item	Encroachments			38.582333 °	38.582333 °
				-121.441506 °	-121.441506 °
DWR ID	DWR_NA0001_04_s_2012_195				
Comment Code					
FE : Fence					
Inspector Comment					
There is a chainlink fence at the levee toe.

04/14/2011 Landscape removed, chainlink fence remains.

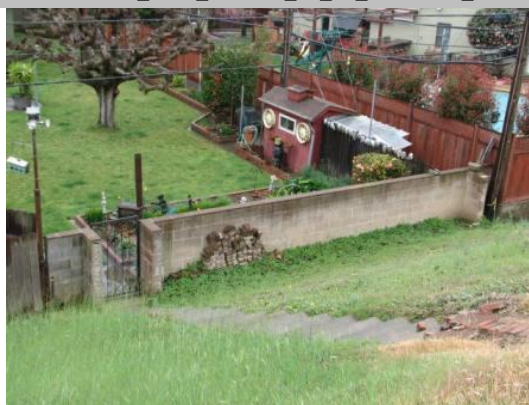
Photo 1 of 1 : SP_2019_NA0001_55_28_20190307_00027.jpg

LM Start	4.35	Rating **	U	Issue No.	28
LM End	4.35	Issue Type +	En	Location *	LS
Category	Earthen Levee			GPS Latitude/Longitude	
				Start	End
Item	Encroachments			38.582186 °	38.582186 °
				-121.441160 °	-121.441160 °
DWR ID	DWR_NA0001_04_s_2012_28				
Comment Code					
FE : Fence					
Inspector Comment					
Cement block fence obstructs access and visibility.

03/16/2012 Cinder block wall obstructs visibility and access.

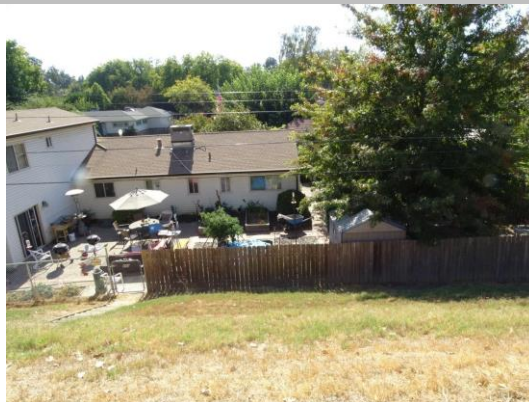
Photo 1 of 2 : SP_2019_NA0001_55_29_20190307_00028.jpg

LM Start	4.36	Rating **	M	Issue No.	29
LM End	4.36	Issue Type +	En	Location *	LS
Category	Earthen Levee			GPS Latitude/Longitude	
				Start	End
Item	Encroachments			38.582083 °	38.582083 °
				-121.440875 °	-121.440875 °
DWR ID	DWR_NA0001_04_s_2012_29				
Comment Code					
FE : Fence					
Inspector Comment					
Wooden fence located at the levee toe obstructs access and visibility.

View of wooden fence at levee toe. Fall 2018

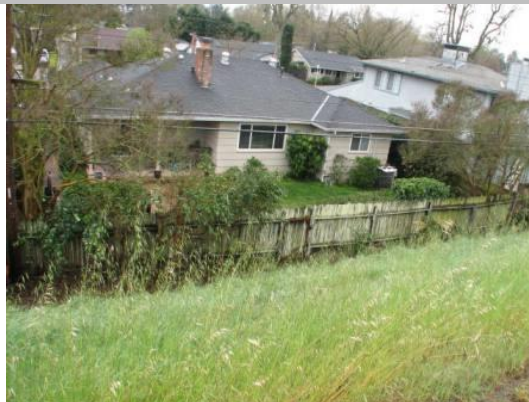
Photo 1 of 1 : SP_2019_NA0001_55_198_20190307_00164.jpg

LM Start	4.41	Rating **	U	Issue No.	198
LM End	4.41	Issue Type +	En	Location *	LS
Category	Earthen Levee			GPS Latitude/Longitude	
				Start	End
Item	Encroachments			38.581788 °	38.581788 °
				-121.440086 °	-121.440086 °
DWR ID	DWR_NA0001_04_s _ 2012_198				
Comment Code					
FE : Fence					
Inspector Comment					
Privacy fence and landscaping within 10-ft of the levee toe obstruct access and visibility.

03/16/2012 Wood privacy fence completely obstructs access and visibility.

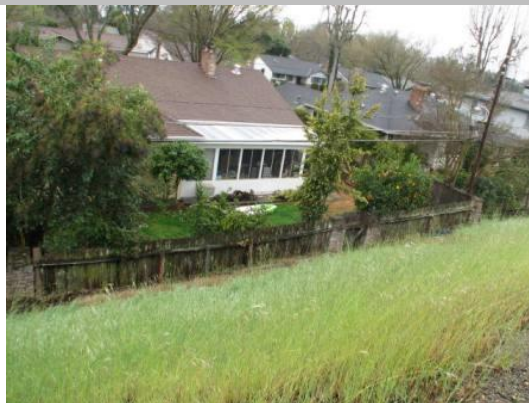
Photo 1 of 1 : SP_2019_NA0001_55_30_20190307_00030.jpg

LM Start	4.42	Rating **	U	Issue No.	30
LM End	4.42	Issue Type +	En	Location *	LS
Category	Earthen Levee			GPS Latitude/Longitude	
				Start	End
Item	Encroachments			38.581724 °	38.581724 °
				-121.439891 °	-121.439891 °
DWR ID	DWR_NA0001_04_s_2012_30				
Comment Code					
FE : Fence					
Inspector Comment					
Privacy fence and landscaping within 10-ft of the levee toe obstruct access and visibility.

03/16/2012 Wood privacy fence completely obstructs access and visibility.

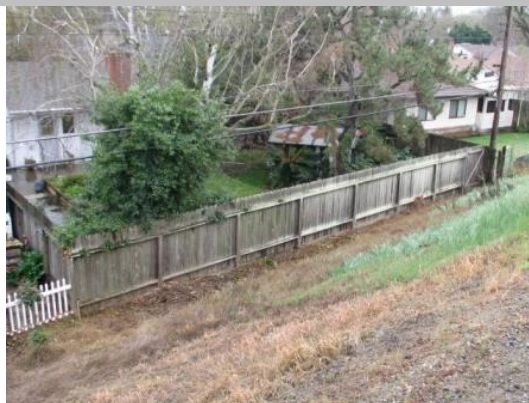
Photo 1 of 1 : SP_2019_NA0001_55_31_20190307_00031.jpg

LM Start	4.47	Rating **	U	Issue No.	31
LM End	4.47	Issue Type +	En	Location *	LS
Category	Earthen Levee			GPS Latitude/Longitude	
				Start	End
Item	Encroachments			38.581495 °	38.581495 °
				-121.439129 °	-121.439129 °
DWR ID	DWR_NA0001_04_s_2012_31				
Comment Code					
FE : Fence					
Inspector Comment					
Wooden fence within 10-ft of the levee toe obstructs access and visibility.

03/16/2012 Wood privacy fence completely obstructs access and visibility.

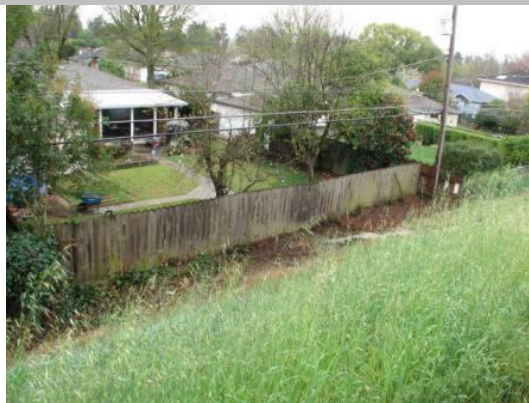
Photo 1 of 1 : SP_2019_NA0001_55_35_20190307_00032.jpg

LM Start	4.53	Rating **	U	Issue No.	35
LM End	4.53	Issue Type +	En	Location *	LS
Category	Earthen Levee			GPS Latitude/Longitude	
				Start	End
Item	Encroachments			38.581246 °	38.581246 °
				-121.438033 °	-121.438033 °
DWR ID	DWR_NA0001_04_s_2012_35				
Comment Code					
FE : Fence					
Inspector Comment					
Wooden fence within 10-ft of the levee toe obstructs access and visibility.

03/16/2012 Wood privacy fence completely obstructs access and visibility.

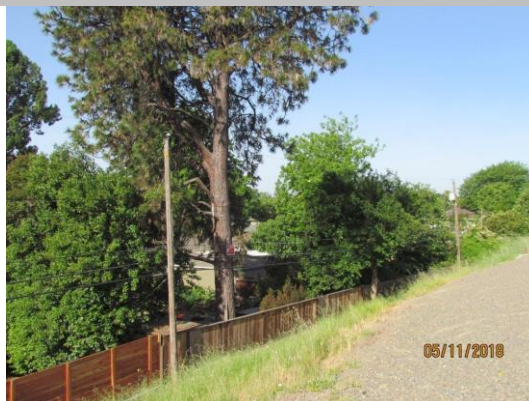
Photo 1 of 2 : SP_2019_NA0001_55_199_20190307_00165.jpg

LM Start	4.54	Rating **	U	Issue No.	199
LM End	4.54	Issue Type +	En	Location *	LS
Category	Earthen Levee			GPS Latitude/Longitude	
				Start	End
Item	Encroachments			38.581205 °	38.581205 °
				-121.437830 °	-121.437830 °
DWR ID	DWR_NA0001_04_s_2012_199				
Comment Code					
FE : Fence					
Inspector Comment					
Wood privacy fence completely obstructs access and visibility. Fruit tree also encroaches on the levee slope.

New wood privacy fence completely obstructs access and visibility, Spring 2018.

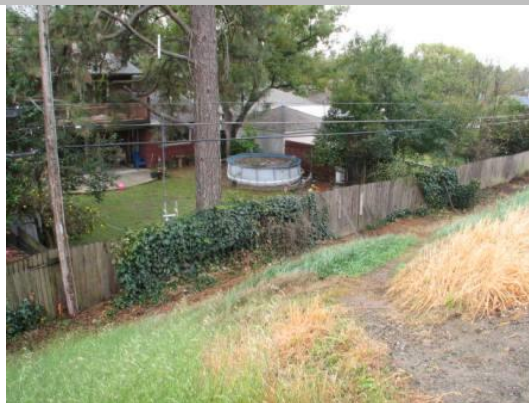
Photo 2 of 2 : SP_2019_NA0001_55_199_20190307_00166.jpg

LM Start	4.54	Rating **	U	Issue No.	199 (cont)	
LM End	4.54	Issue Type +	En	Location *	LS	
Category	Earthen Levee			GPS Latitude/Longitude		
				Start		End
Item	Encroachments			38.581205 °		38.581205 °
				-121.437830 °		-121.437830 °
DWR ID	DWR_NA0001_04_s _ 2012_199					
Comment Code						
FE : Fence						
Inspector Comment						
Wood privacy fence completely obstructs access and visibility. Fruit tree also encroaches on the levee slope.

03/16/2012 Wood privacy fence completely obstructs access and visibility.

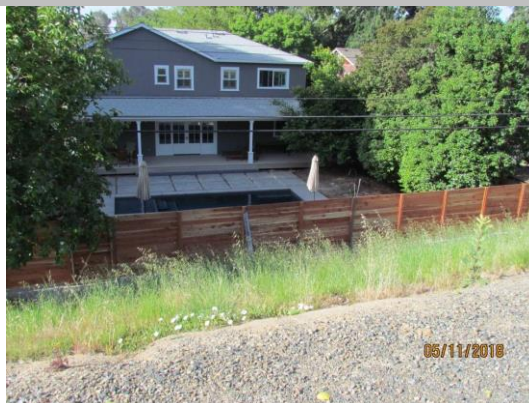
Photo 1 of 2 : SP_2019_NA0001_55_200_20190307_00167.jpg

LM Start	4.55	Rating **	U	Issue No.	200
LM End	4.55	Issue Type +	En	Location *	LS
Category	Earthen Levee			GPS Latitude/Longitude	
				Start	End
Item	Encroachments			38.581178 °	38.581178 °
				-121.437584 °	-121.437584 °
DWR ID	DWR_NA0001_04_s _ 2012_200				
Comment Code					
FE : Fence					
Inspector Comment					
Remodel, new pool, and new fence; the privacy fence completely obstructs access and visibility.

View of the new remodel, new pool, and new fence; the privacy fence completely obstructs access and visibility, Spring 2018.

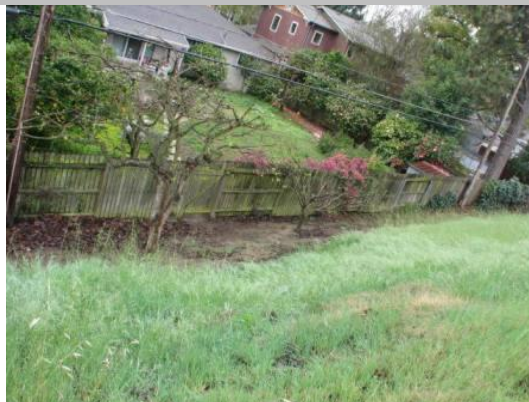
Photo 2 of 2 : SP_2019_NA0001_55_200_20190307_00168.jpg

03/16/2012 Wood privacy fence completely obstructs access and visibility.

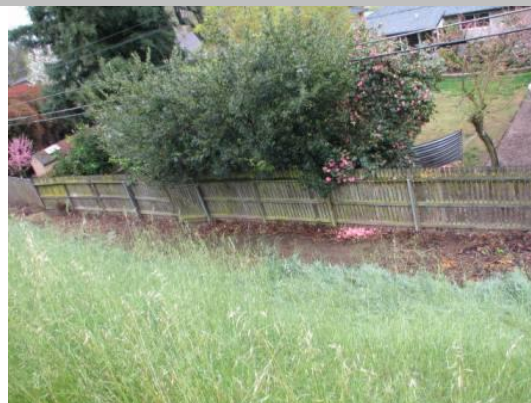
Photo 1 of 1 : SP_2019_NA0001_55_201_20190307_00169.jpg

LM Start	4.57	Rating **	U	Issue No.	201
LM End	4.57	Issue Type +	En	Location *	LS
Category	Earthen Levee			GPS Latitude/Longitude	
				Start	End
Item	Encroachments			38.581155 °	38.581155 °
				-121.437320 °	-121.437320 °
DWR ID	DWR_NA0001_04_s _ 2012_201				
Comment Code					
FE : Fence					
Inspector Comment					
A privacy fence within 10-ft of the levee toe obstructs access and visibility.

03/16/2012 Wood privacy fence completely obstructs access and visibility.

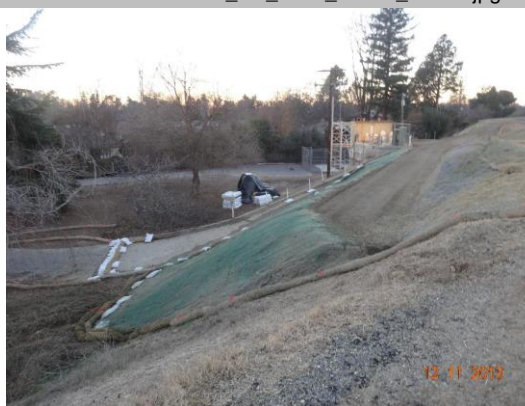
Photo 1 of 3 : UCIP_SP_2019_31446_57490.jpg

LM Start	4.61	Rating **	M	Issue No.	762
LM End	4.61	Issue Type +	En	Location *	
Category	Supplemental			GPS Latitude/Longitude	
				Start	End
Item	DWR UCIP Field Study			38.581101 °	38.581101 °
				-121.436502 °	-121.436502 °
DWR ID	24808				
Comment Code					
Inspector Comment					
FS_ID:31446					
DS_ID:24808					
EP_NO: N/A					
Repair Type: Non-Urgent					
Crossing Status: Indicator Found					
UCIP Comments: New construction--need permit and details on crossing.					
FIELD_STRUCT_DESC: 1 of 4: Concrete service box located on waterside (WS) shoulder. Landside (LS) has been regraded. No permit was found for the work. Unable to verify if crossing crosses levee.					
FS Date: 12/13/2013

View of landward side.

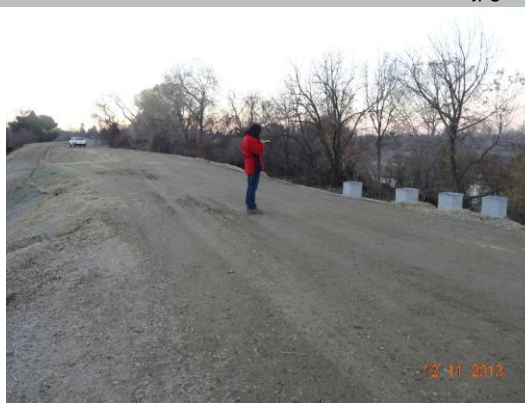
Photo 2 of 3 : UCIP_SP_2019_31446_57489.jpg

View of regraded levee crown with service boxes on waterward slope.

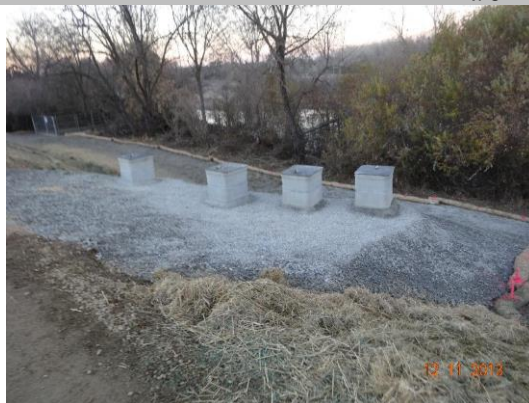
Photo 3 of 3 : UCIP_SP_2019_31446_57488.jpg

LM Start	4.61	Rating **	M	Issue No.	762 (cont)	
LM End	4.61	Issue Type +	En	Location *		
Category	Supplemental			GPS Latitude/Longitude		
				Start	End	
Item	DWR UCIP Field Study			38.581101 °	38.581101 °	
				-121.436502 °	-121.436502 °	
DWR ID	24808					
Comment Code						
Inspector Comment						
FS_ID:31446						
DS_ID:24808						
EP_NO: N/A						
Repair Type: Non-Urgent						
Crossing Status: Indicator Found						
UCIP Comments: New construction--need permit and details on crossing.						
FIELD_STRUCT_DESC: 1 of 4: Concrete service box located on waterside (WS) shoulder. Landside (LS) has been regraded. No permit was found for the work. Unable to verify if crossing crosses levee.						
FS Date: 12/13/2013

Service boxes located on waterward shoulder.

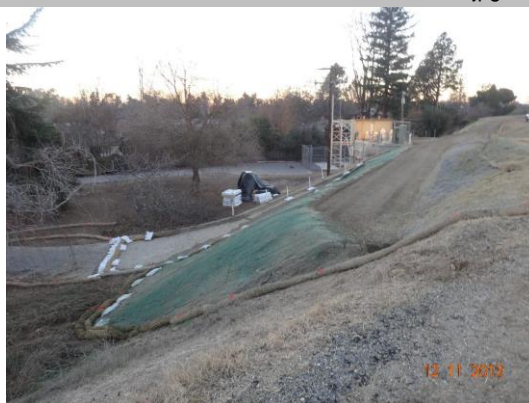
Photo 1 of 3 : UCIP_SP_2019_31447_57493.jpg

LM Start	4.61	Rating **	M	Issue No.	763	
LM End	4.61	Issue Type +	En	Location *		
Category	Supplemental			GPS Latitude/Longitude		
				Start	End	
Item	DWR UCIP Field Study			38.581092 °	38.581092 °	
				-121.436466 °	-121.436466 °	
DWR ID	24809					
Comment Code						
Inspector Comment						
FS_ID:31447						
DS_ID:24809						
EP_NO: N/A						
Repair Type: Non-Urgent						
Crossing Status: Indicator Found						
UCIP Comments: New construction; no permit found; Need additional information about crossings to determine whether crossings penetrate levee.						
FIELD_STRUCT_DESC: 2 of 4: Concrete service box located on waterside (WS) shoulder. Landside (LS) has been regraded. No permit was found for the work. Unable to verify if crossing crosses levee.						
FS Date: 12/13/2013

View of landward side.

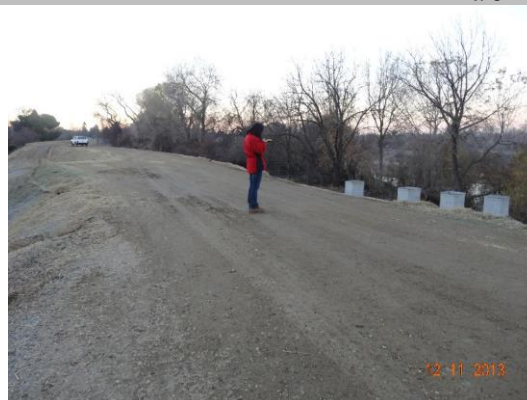
Photo 2 of 3 : UCIP_SP_2019_31447_57492.jpg

LM Start	4.61	Rating **	M	Issue No.	763 (cont)	
LM End	4.61	Issue Type +	En	Location *		
Category	Supplemental			GPS Latitude/Longitude		
				Start	End	
Item	DWR UCIP Field Study			38.581092 °	38.581092 °	
				-121.436466 °	-121.436466 °	
DWR ID	24809					
Comment Code						
Inspector Comment						
FS_ID:31447						
DS_ID:24809						
EP_NO: N/A						
Repair Type: Non-Urgent						
Crossing Status: Indicator Found						
UCIP Comments: New construction; no permit found; Need additional information about crossings to determine whether crossings penetrate levee.						
FIELD_STRUCT_DESC: 2 of 4: Concrete service box located on waterside (WS) shoulder. Landside (LS) has been regraded. No permit was found for the work. Unable to verify if crossing crosses levee.						
FS Date: 12/13/2013

View of levee crown at crossings.

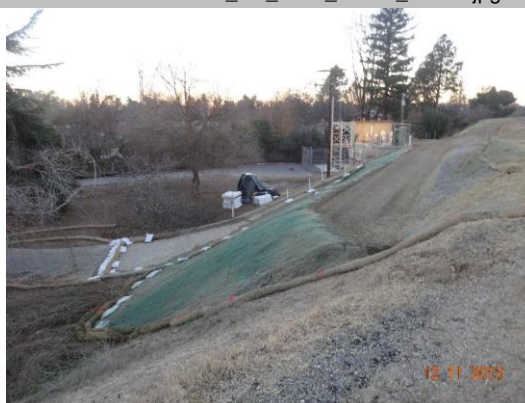
Photo 1 of 3 : UCIP_SP_2019_31448_57496.jpg

LM Start	4.61	Rating **	M	Issue No.	764
LM End	4.61	Issue Type +	En	Location *	
Category	Supplemental			GPS Latitude/Longitude	
				Start	End
Item	DWR UCIP Field Study			38.581087 °	38.581087 °
				-121.436449 °	-121.436449 °
DWR ID	24810				
Comment Code					
Inspector Comment					
FS_ID:31448					
DS_ID:24810					
EP_NO: N/A					
Repair Type: Non-Urgent					
Crossing Status: Indicator Found					
UCIP Comments: New construction; no permit found; Need additional information about crossings to determine whether crossings penetrate levee.					
FIELD_STRUCT_DESC: 3 of 4: Concrete service box located on waterside (WS) shoulder. Landside (LS) has been regraded. No permit was found for the work. Unable to verify if crossing crosses levee.					
FS Date: 12/13/2013

View of landward side.

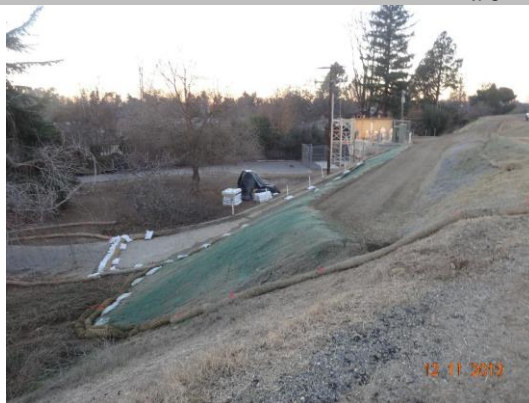
Photo 1 of 3 : UCIP_SP_2019_31449_57499.jpg

LM Start	4.61	Rating **	M	Issue No.	765
LM End	4.61	Issue Type +	En	Location *	
Category	Supplemental			GPS Latitude/Longitude	
				Start	End
Item	DWR UCIP Field Study			38.581082 °	38.581082 °
				-121.436431 °	-121.436431 °
DWR ID	24811				
Comment Code					
Inspector Comment					
FS_ID:31449 DS_ID:24811 EP_NO: N/A Repair Type: Non-Urgent Crossing Status: Indicator Found UCIP Comments: New construction; no permit found; Need additional information about crossings to determine whether crossing penetrate levee. FIELD_STRUCT_DESC: 4 of 4: Concrete service box located on waterside (WS) shoulder. Landside (LS) has been regraded. No permit was found for the work. Unable to verify if crossing crosses levee. FS Date: 12/13/2013

View of landward side.

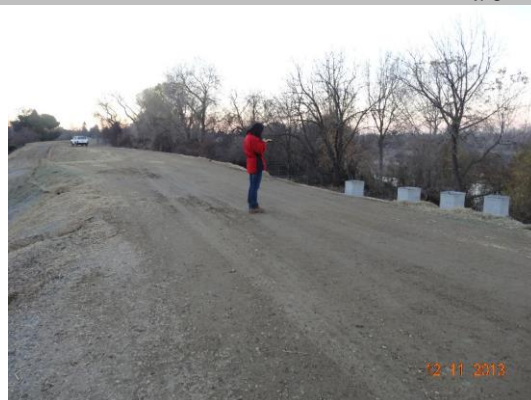
Photo 2 of 3 : UCIP_SP_2019_31449_57498.jpg

LM Start	4.61	Rating **	M	Issue No.	765 (cont)	
LM End	4.61	Issue Type +	En	Location *		
Category	Supplemental			GPS Latitude/Longitude		
				Start	End	
Item	DWR UCIP Field Study			38.581082 °	38.581082 °	
				-121.436431 °	-121.436431 °	
DWR ID	24811					
Comment Code						
Inspector Comment						
FS_ID:31449						
DS_ID:24811						
EP_NO: N/A						
Repair Type: Non-Urgent						
Crossing Status: Indicator Found						
UCIP Comments: New construction; no permit found; Need additional information about crossings to determine whether crossing penetrate levee.						
FIELD_STRUCT_DESC: 4 of 4: Concrete service box located on waterside (WS) shoulder. Landside (LS) has been regraded. No permit was found for the work. Unable to verify if crossing crosses levee.						
FS Date: 12/13/2013

View of levee crown.

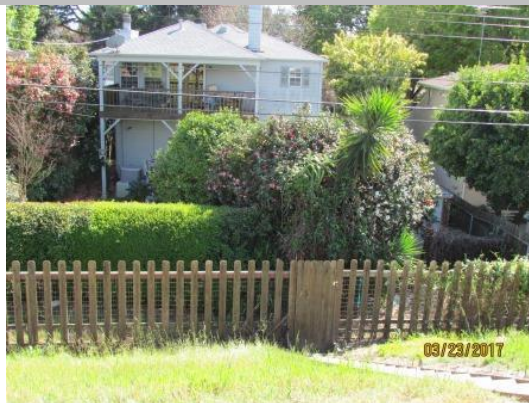
Photo 1 of 1 : SP_2019_NA0001_55_41_20190307_00034.jpg

LM Start	4.74	Rating **	M	Issue No.	41
LM End	4.74	Issue Type +	En	Location *	LS
Category	Earthen Levee			GPS Latitude/Longitude	
				Start	End
Item	Encroachments			38.580753 °	38.580753 °
				-121.434077 °	-121.434077 °
DWR ID	DWR_NA0001_04_s _ 2012_41				
Comment Code					
FE : Fence					
Inspector Comment					
Privacy fence and landscaping within 10-ft of the levee toe obstruct access and visibility.

View of the fence at the levee toe.

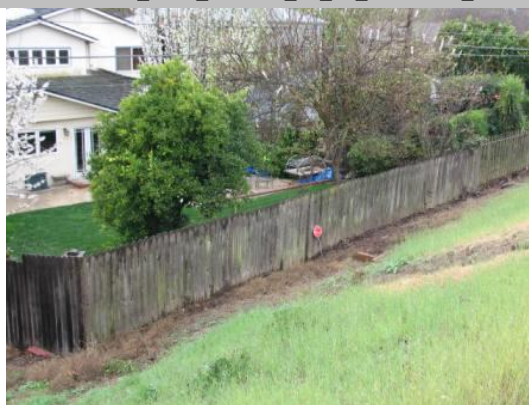
Photo 1 of 1 : SP_2019_NA0001_55_42_20190307_00035.jpg

LM Start	4.76	Rating **	U	Issue No.	42
LM End	4.76	Issue Type +	En	Location *	LS
Category	Earthen Levee			GPS Latitude/Longitude	
				Start	End
Item	Encroachments			38.580744 °	38.580744 °
				-121.433868 °	-121.433868 °
DWR ID	DWR_NA0001_04_s _ 2012_42				
Comment Code					
FE : Fence					
Inspector Comment					
A privacy fence within 10-ft of the levee toe obstructs access and visibility.

03/16/2012 Wood privacy fence completely obstructs access and visibility.

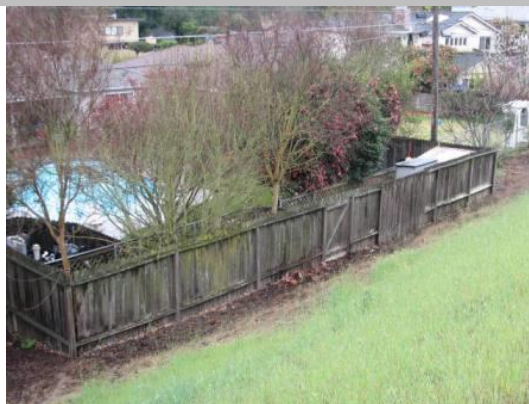
Photo 1 of 1 : SP_2019_NA0001_55_43_20190307_00036.jpg

LM Start	4.78	Rating **	U	Issue No.	43
LM End	4.78	Issue Type +	En	Location *	LS
Category	Earthen Levee			GPS Latitude/Longitude	
				Start	End
Item	Encroachments			38.580731 °	38.580731 °
				-121.433490 °	-121.433490 °
DWR ID	DWR_NA0001_04_s _ 2012_43				
Comment Code					
FE : Fence					
Inspector Comment					
Privacy fence and storage sheds within 10-ft of the levee toe obstruct access and visibility.

03/16/2012 Wood privacy fence completely obstructs access and visibility.

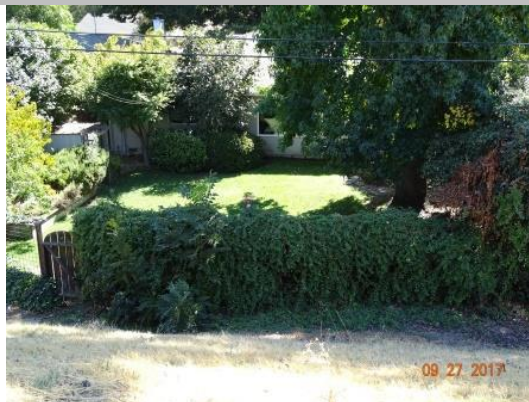
Photo 1 of 1 : SP_2019_NA0001_55_44_20190307_00037.jpg

LM Start	4.85	Rating **	M	Issue No.	44
LM End	4.85	Issue Type +	En	Location *	LS
Category	Earthen Levee			GPS Latitude/Longitude	
				Start	End
Item	Vegetation			38.580747 °	38.580747 °
				-121.432039 °	-121.432039 °
DWR ID	DWR_NA0001_04_f_2018_44				
Comment Code					
V6 : Landscaping					
Inspector Comment					
Vines on wire fence obstruct visibility.

View of the vegetation at the levee toe.

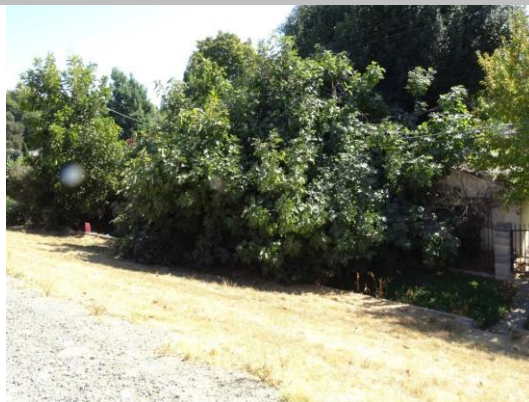
Photo 1 of 2 : SP_2019_NA0001_55_206_20190307_00171.jpg

LM Start	4.87	Rating **	U	Issue No.	206
LM End	4.87	Issue Type +	En	Location *	LS
Category	Earthen Levee			GPS Latitude/Longitude	
				Start	End
Item	Vegetation			38.580778 °	38.580778 °
				-121.431704 °	-121.431704 °
DWR ID	DWR_NA0001_04_s_2012_206				
Comment Code					
V6 : Landscaping					
Inspector Comment					
Fig tree obstructs visibility and access.

View of landscaping that obstructs visibility and access. Fall 2018

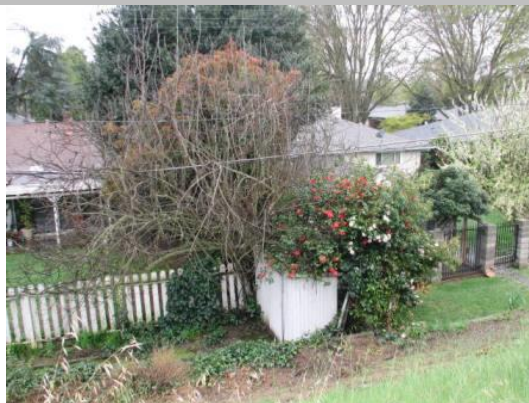
Photo 2 of 2 : SP_2019_NA0001_55_206_20190307_00172.jpg

LM Start	4.87	Rating **	U	Issue No.	206 (cont)	
LM End	4.87	Issue Type +	En	Location *	LS	
Category	Earthen Levee			GPS Latitude/Longitude		
				Start		End
Item	Vegetation			38.580778 °		38.580778 °
				-121.431704 °		-121.431704 °
DWR ID	DWR_NA0001_04_s _ 2012_206					
Comment Code						
V6 : Landscaping						
Inspector Comment						
Fig tree obstructs visibility and access.

03/16/2012 Landscaping obstructs visibility and access.

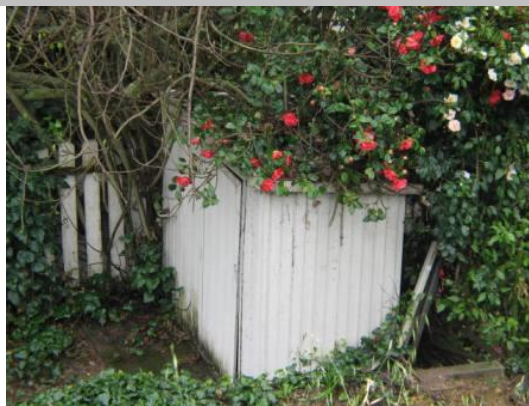
Photo 1 of 1 : SP_2019_NA0001_55_96_20190307_00082.jpg

LM Start	4.87	Rating **	U	Issue No.	96
LM End	4.87	Issue Type +	En	Location *	LS
Category	Earthen Levee			GPS Latitude/Longitude	
				Start	End
Item	Encroachments			38.580767 °	38.580767 °
				-121.431684 °	-121.431684 °
DWR ID	DWR_NA0001_04_s _ 2012_96				
Comment Code					
BU : Building					
Inspector Comment					
Wooden shed is located within the levee easement beneath the fig tree.

3/16/2012 Structure is within 15' of levee toe.

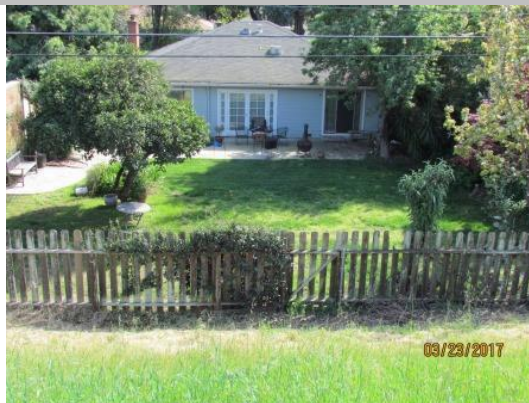
Photo 1 of 1 : SP_2019_NA0001_55_265_20190307_00205.jpg

LM Start	4.89	Rating **	M	Issue No.	265
LM End	4.89	Issue Type +	En	Location *	LS
Category	Earthen Levee			GPS Latitude/Longitude	
				Start	End
Item	Encroachments			38.580794 °	38.580794 °
				-121.431453 °	-121.431453 °
DWR ID	DWR_NA0001_04_s _ 2017_265				
Comment Code					
FE : Fence					
Inspector Comment					
A fence is located at the levee toe.

View of the fence at the levee toe.

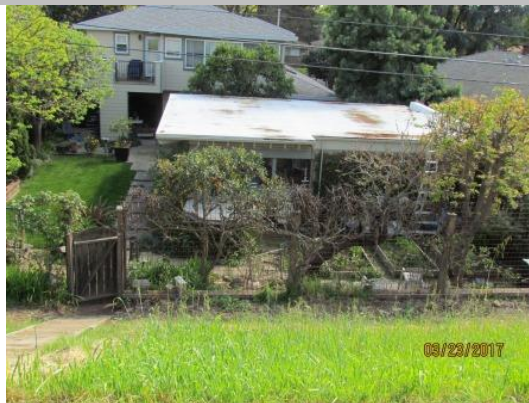
Photo 1 of 1 : SP_2019_NA0001_55_207_20190307_00173.jpg

LM Start	4.90	Rating **	M	Issue No.	207
LM End	4.90	Issue Type +	En	Location *	LS
Category	Earthen Levee			GPS Latitude/Longitude	
				Start	End
Item	Encroachments			38.580806 °	38.580806 °
				-121.431266 °	-121.431266 °
DWR ID	DWR_NA0001_04_s _ 2012_207				
Comment Code					
FE : Fence					
Inspector Comment					
A fence is located at the levee toe.

View of the fence at the levee toe.

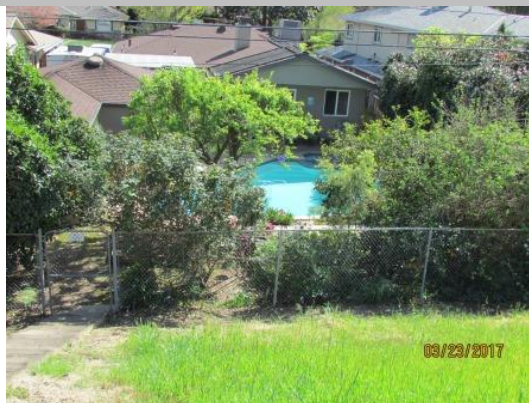
Photo 1 of 1 : SP_2019_NA0001_55_264_20190307_00204.jpg

LM Start	4.91	Rating **	M	Issue No.	264
LM End	4.91	Issue Type +	En	Location *	LS
Category	Earthen Levee			GPS Latitude/Longitude	
				Start	End
Item	Encroachments			38.580820 °	38.580820 °
				-121.431045 °	-121.431045 °
DWR ID	DWR_NA0001_04_s _ 2017_264				
Comment Code					
FE : Fence					
Inspector Comment					
A chain-link fence is located at the levee toe.

View of the fence at the levee toe.

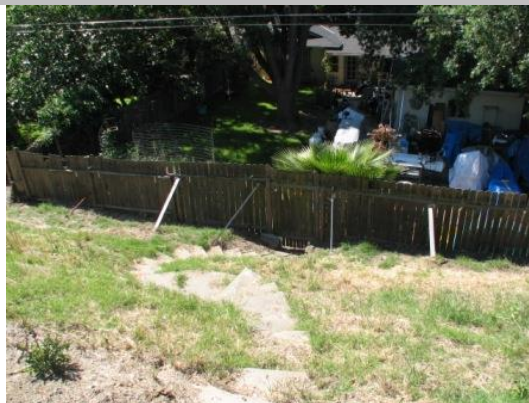
Photo 1 of 1 : SP_2019_NA0001_55_45_20190307_00038.jpg

LM Start	4.93	Rating **	U	Issue No.	45
LM End	4.93	Issue Type +	En	Location *	LS
Category	Earthen Levee			GPS Latitude/Longitude	
				Start	End
Item	Encroachments			38.580844 °	38.580844 °
				-121.430672 °	-121.430672 °
DWR ID	DWR_NA0001_04_s _ 2012_45				
Comment Code					
FE : Fence					
Inspector Comment					
Wooden fence with bracing obstructs access and visibility.

Wooden fence and braces obstruct access and visibility.

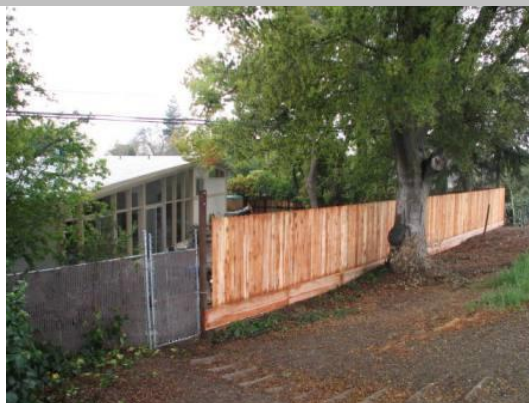
Photo 1 of 1 : SP_2019_NA0001_55_208_20190307_00174.jpg

LM Start	5.13	Rating **	U	Issue No.	208
LM End	5.13	Issue Type +	En	Location *	LS
Category	Earthen Levee			GPS Latitude/Longitude	
				Start	End
Item	Encroachments			38.580882 °	38.580882 °
				-121.427038 °	-121.427038 °
DWR ID	DWR_NA0001_04_s _ 2012_208				
Comment Code					
FE : Fence					
Inspector Comment					
A privacy fence with lattice and landscaping within 10-ft of the levee toe obstruct access and visibility.

03/16/2012 Wood privacy fence completely obstructs access and visibility.

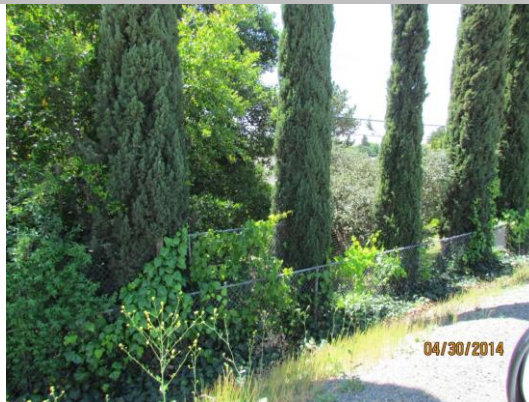
Photo 1 of 1 : SP_2019_NA0001_55_47_20190307_00040.jpg

LM Start	5.15	Rating **	M	Issue No.	47
LM End	5.15	Issue Type +	En	Location *	LS
Category	Earthen Levee			GPS Latitude/Longitude	
				Start	End
Item	Encroachments			38.580773 °	38.580773 °
				-121.426691 °	-121.426691 °
DWR ID	DWR_NA0001_04_s _ 2012_47				
Comment Code					
FE : Fence					
Inspector Comment					
Chain link fence, helix sky pencil, and landscaping within 10-ft of the levee toe obstruct access and visibility.

View of the fence and vegetation at the landside levee toe.

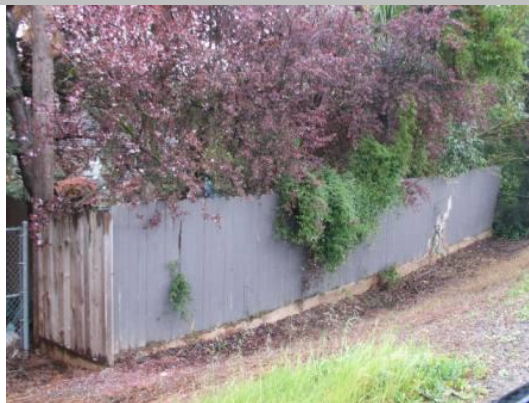
Photo 1 of 1 : SP_2019_NA0001_55_48_20190307_00041.jpg

LM Start	5.17	Rating **	U	Issue No.	48
LM End	5.17	Issue Type +	En	Location *	LS
Category	Earthen Levee			GPS Latitude/Longitude	
				Start	End
Item	Encroachments			38.580622 °	38.580622 °
				-121.426372 °	-121.426372 °
DWR ID	DWR_NA0001_04_s _ 2012_48				
Comment Code					
FE : Fence					
Inspector Comment					
Wood privacy fence and landscaping within 10-ft of the levee toe obstruct access and visibility.

03/16/2012 Wood privacy fence completely obstructs access and visibility.

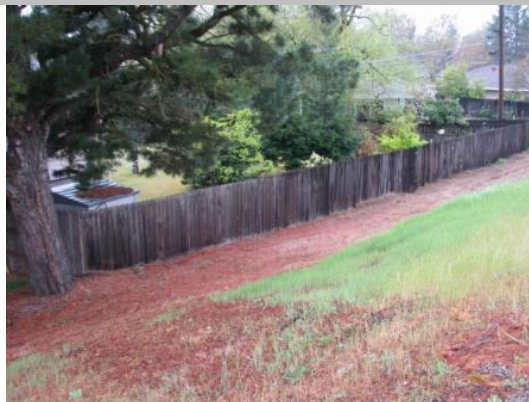
Photo 1 of 1 : SP_2019_NA0001_55_49_20190307_00042.jpg

LM Start	5.45	Rating **	U	Issue No.	49
LM End	5.45	Issue Type +	En	Location *	LS
Category	Earthen Levee			GPS Latitude/Longitude	
				Start	End
Item	Encroachments			38.577526 °	38.577526 °
				-121.423349 °	-121.423349 °
DWR ID	DWR_NA0001_04_s _ 2012_49				
Comment Code					
FE : Fence					
Inspector Comment					
Wood privacy fence within 10-ft of the levee toe obstruct access and visibility.

03/16/2012 Wood privacy fence completely obstructs access and visibility.

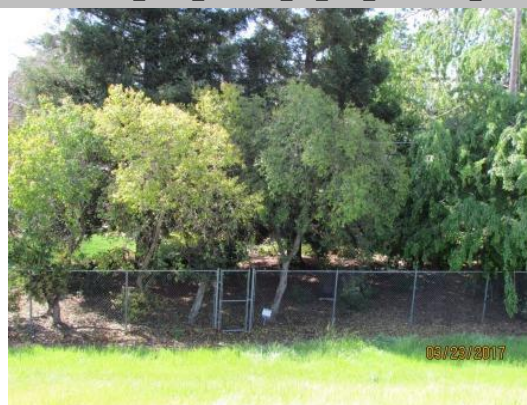
Photo 1 of 1 : SP_2019_NA0001_55_263_20190307_00203.jpg

LM Start	5.48	Rating **	M	Issue No.	263
LM End	5.48	Issue Type +	En	Location *	LS
Category	Earthen Levee			GPS Latitude/Longitude	
				Start	End
Item	Encroachments			38.577065 °	38.577065 °
				-121.423255 °	-121.423255 °
DWR ID	DWR_NA0001_04_s_2017_263				
Comment Code					
FE : Fence					
Inspector Comment					
Chain-link fence at levee toe does not appear to be permitted.

View of the fence at the levee toe.

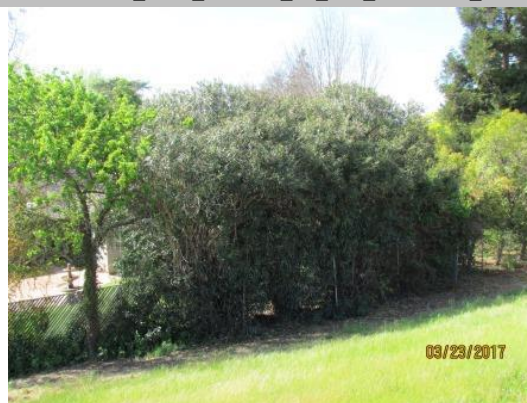
Photo 1 of 1 : SP_2019_NA0001_55_209_20190307_00175.jpg

LM Start	5.49	Rating **	M	Issue No.	209
LM End	5.49	Issue Type +	En	Location *	LS
Category	Earthen Levee			GPS Latitude/Longitude	
				Start	End
Item	Vegetation			38.576878 °	38.576878 °
				-121.423234 °	-121.423234 °
DWR ID	DWR_NA0001_04_s_2012_209				
Comment Code					
V6 : Landscaping					
Inspector Comment					
Oleanders within 10-ft of the levee toe obstruct access and visibility.

View of the shrubs at the levee toe.

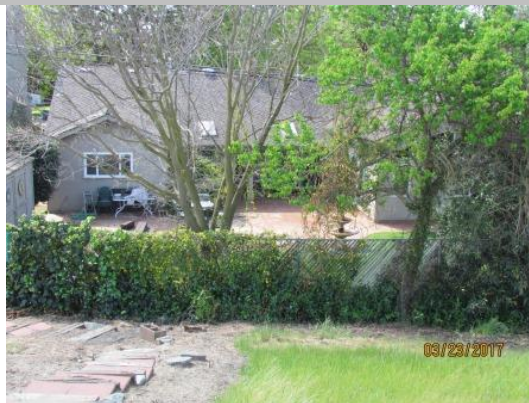
Photo 1 of 1 : SP_2019_NA0001_55_262_20190307_00202.jpg

LM Start	5.50	Rating **	U	Issue No.	262
LM End	5.50	Issue Type +	En	Location *	LS
Category	Earthen Levee			GPS Latitude/Longitude	
				Start	End
Item	Encroachments			38.576796 °	38.576796 °
				-121.423221 °	-121.423221 °
DWR ID	DWR_NA0001_04_s_2017_262				
Comment Code					
FE : Fence					
Inspector Comment					
Verify whether chainlink fence with landscaping is also authorized under 6477 since it is obstructing visibility and access at landside levee toe.

View of the fence at the levee toe.

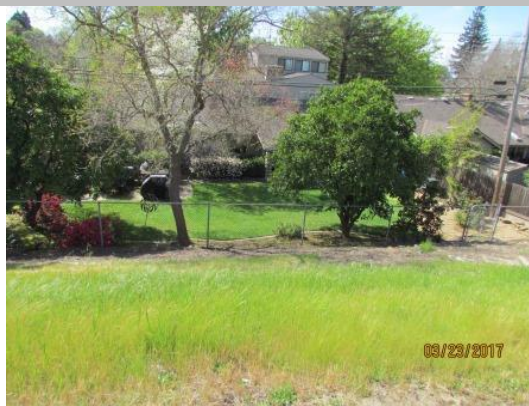
Photo 1 of 1 : SP_2019_NA0001_55_261_20190307_00201.jpg

LM Start	5.51	Rating **	M	Issue No.	261
LM End	5.51	Issue Type +	En	Location *	LS
Category	Earthen Levee			GPS Latitude/Longitude	
				Start	End
Item	Encroachments			38.576579 °	38.576579 °
				-121.423201 °	-121.423201 °
DWR ID	DWR_NA0001_04_s_2017_261				
Comment Code					
FE : Fence					
Inspector Comment					
Chainlink fence at levee toe does not appear to be permitted, but the paver stairs are authorized under 6480.

View of the fence at the levee toe.
